Collector Wind Farm

Wind Turbine Micrositing Assessment

May 2019

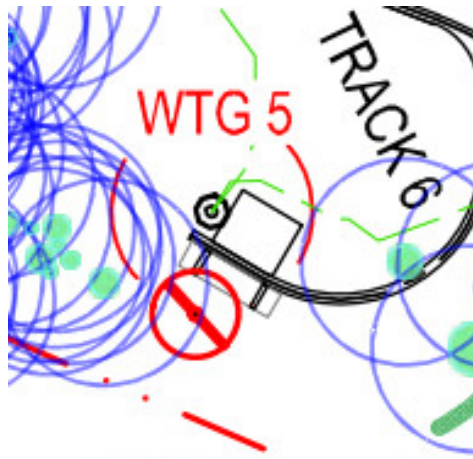
Wind turbine moved 26m east to ensure minimal infrastructure overlap of the preferred protective buffer zone around the identified Aboriginal heritage item (reference SU45/L1). This also moves the wind turbine location to be more than 60m from the nearest identified hollow bearing tree (HBT), compared to the original proposed location.

- Black circle / hexagon = WTG centre point
- Small red circle = heritage item buffer
- Green dots = identified HBTs
- Blue circles = 60m tree protection zone (HBTs)

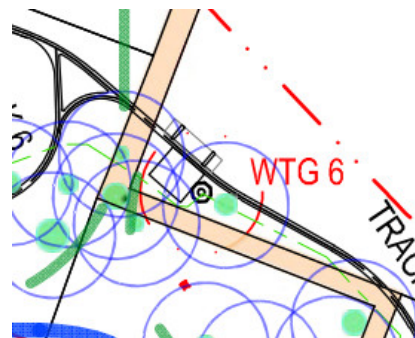
Figure 3b: WTG6 Alt Location

Wind turbine moved 90m east to bring turbine onto higher ground above ground 'hollow' which was the originally approved location. This avoids the need for construction of specific access track, thereby reducing overall clearing of box gum woodland vegetation and avoiding potential tree clearance in that area.

The revised location does intrude into the 60m TPZ of several HBTs in the vicinity, but it is noted that the original approved location similarly affected the TPZ of several HBTs and hence there would be no additional HBT impact from the proposed move. It is also noted that the intention is to protect all the identified HBTs in the vicinity of WTG 6 during both construction and operation.

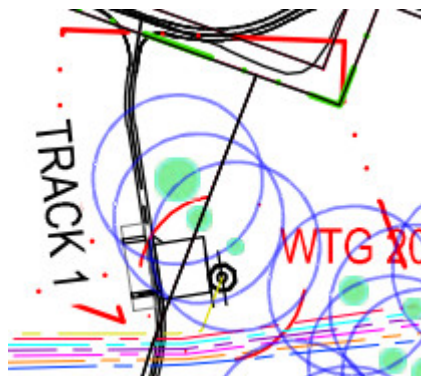
Wind turbine moved 66m to the north, following redesign of layout around the site access toward the construction compound. Basis is to remove 'safety clearance zone' from overhanging construction compound during crane erection activities for wind turbine.

- Black circle / hexagon = WTG location
- Green dots = identified HBTs
- Blue circles = 60m tree protection zone (HBTs)

The revised location does intrude into the 60m TPZ of several HBTs in the vicinity, but it is noted that the original approved location similarly affected the TPZ of several HBTs and hence there would be no additional HBT impact from the proposed move. It is also noted that the intention is to protect all the identified HBTs in the vicinity of WTG 20 during both construction and operation.

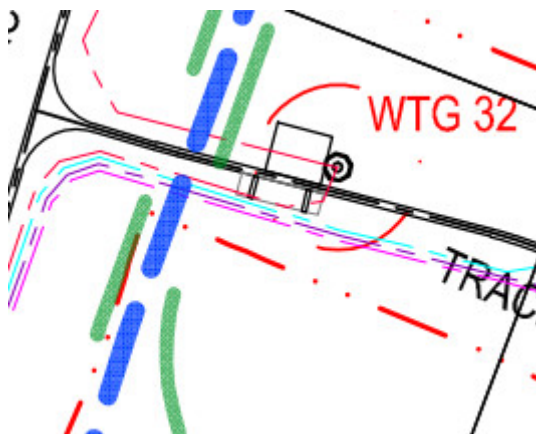
Figure 9: WTG32 Alt Location

Wind turbine moved 30m north to be consistent with the wind turbine spacing design requirement of 2.5 times blade diameter separation between turbines.

The revised location has no effect on the current impacts of the project.

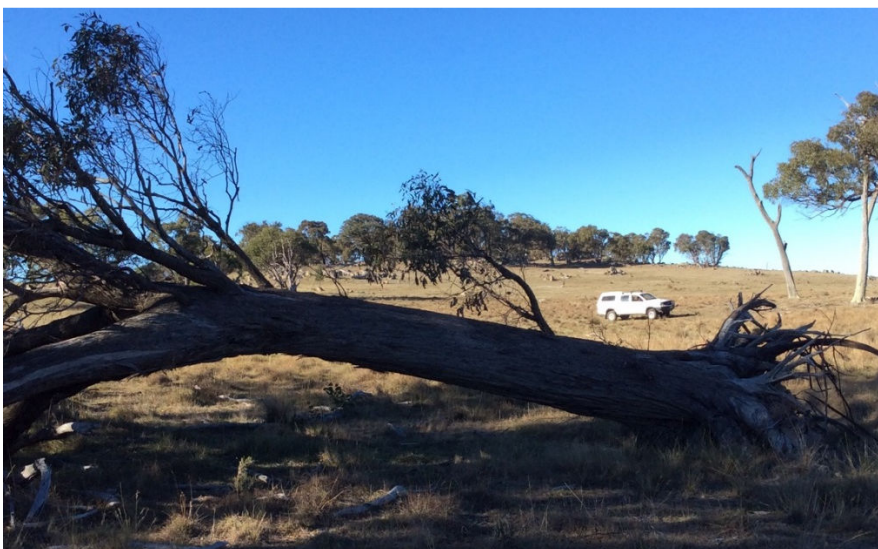
It was identified during the surveys that one of the HBTs previously recorded at the site and documented within the Biodiversity Assessment Addendum (NGH Environmental September 2015), had fallen down in the intervening time. This HBT was located to the north of Turbine 61 and in between HBT201 and HBT 204 in the current data. This tree (shown in Figure 1 below) has not been included within the current data as it no longer provides habitat as a HBT.

Figure 1 The tree previously identified as hollow-bearing which is no longer standing
