Rehabilitation Plan & Guidelines

Mount Emerald Wind Farm

Report prepared for RPS Australia Asia Pacific (Cairns) for MEWFPL
Reference: SG1612

December 2016

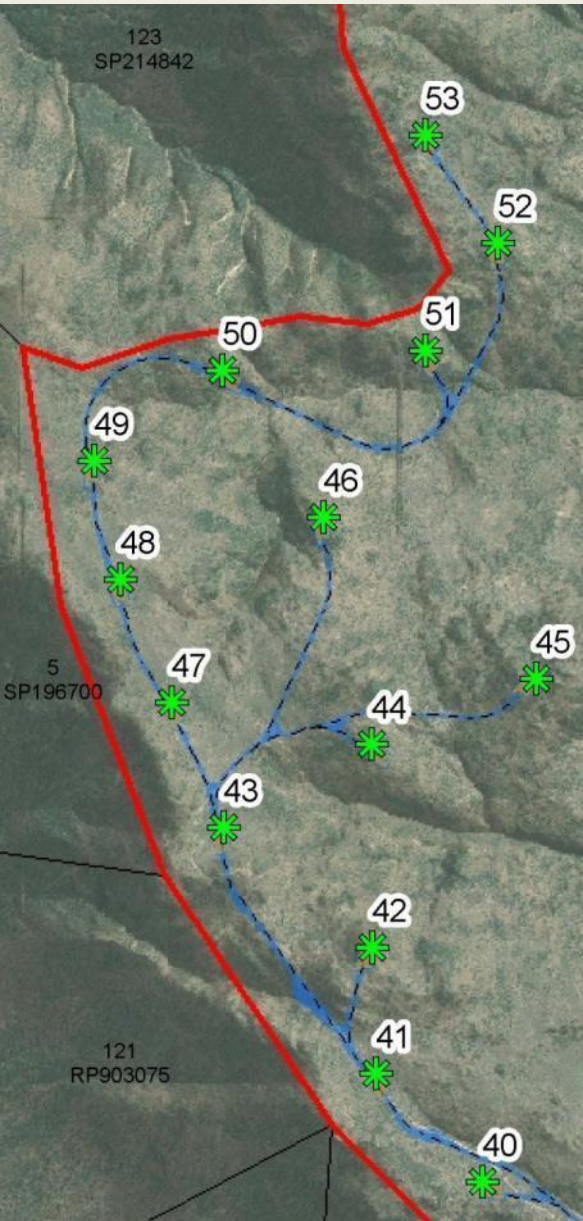
REHABILITATION AREA 1

<p>AREA DESCRIPTION</p> <p>Includes WTG's 40 to 53.</p> <p>All tracks and cabling between WTG's.</p> <p>ENVIRONMENTAL FEATURES</p> <p>Rolling hills with minor areas of rock outcrop.</p> <p>Clay soils start to develop around southern section of rehabilitation area.</p> <p>Shallow to moderately incised drainage line crossings near WTG 50 and WTG 51.</p> <p>Elevated rocky area around WTG 53 with different species composition.</p> <p>Common trees include <i>Corymbia citriodora</i> and <i>Eucalyptus mediocris</i>. Large trees of Cypress Pine (<i>Callitris intratropica</i>) near WTG 51 close to watercourse crossing.</p> <p>Dominant grass is <i>Themeda triandra</i> (Kangaroo Grass). <i>Arundinella setosa</i> and <i>Heteropogon triticeus</i> (Giant Spear Grass) are also common in places.</p> <p>REHABILITATION RECOMMENDATIONS</p> <p>Use field-based observations to determine species composition.</p> <p>Apply specific plant species to unique vegetation types and habitats: watercourse banks, rocky outcrops, flat, clay areas (close to WTG 40 and 41).</p> <p>Do not clear large Cypress Pine trees (<i>Callitris intratropica</i>) near watercourse crossing south of WTG 51 or other areas where large specimens of this species are encountered.</p> <p>Avoid clearing any large-class trees (Eucalypts >30 cm dbh, non-Eucalypts >20 cm dbh).</p> <p>Allow and promote natural regeneration of track edges.</p> <p>Limit use of herbicides to absolute minimum and only when necessary. Weed control should be site and species specific and undertaken in accordance with the MEWF Weed Management Plan.</p> <p>Transplant grass trees (<i>Xanthorrhoea johnsonii</i>).</p>

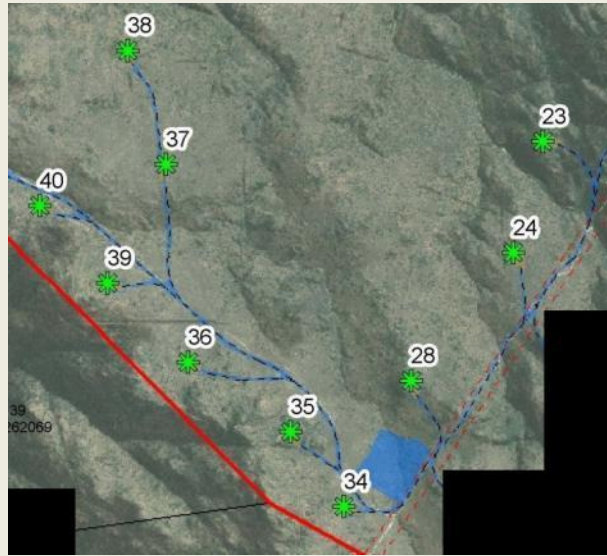
REHABILITATION AREA 2

Includes WTG's 23, 24, 28, 34 to 40, Substation and Substation O&M Building.

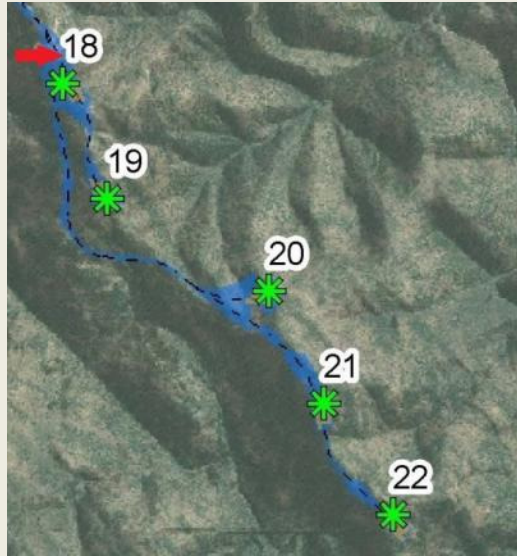
REHABILITATION AREA 4

Includes WTG's 18 to 22 on elevated ridges south of the 275 kV powerline.
